# Archaeology and... ...new discoveries

## Courtyard at Culross

## Crathes Castle's frozen secrets

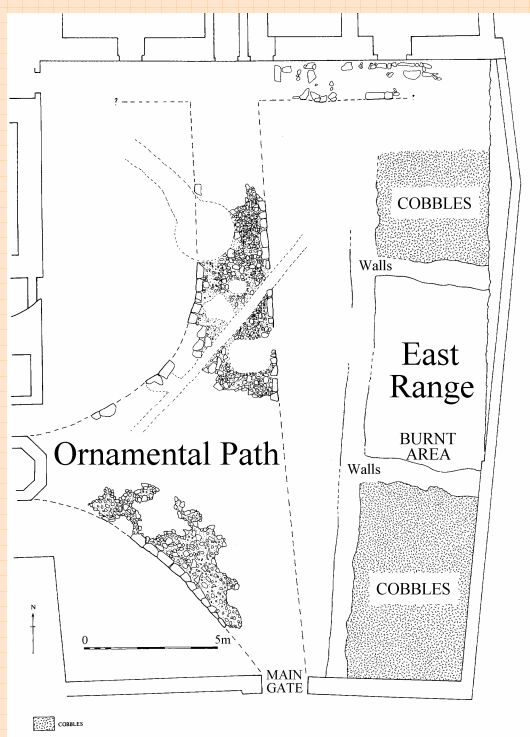
The excavation plan clearly shows the curve of the pathway

Re-organisation of the late 16th/17th-century 'courtyard' of Culross Palace in Fife showed that originally this had not been a courtyard at all. A range of buildings was found to fill much of the area. They included the surviving hearth of a smithy, and the intact cobbled floor of a stables.

A wide, curving decorative path leading to the principal entrances showed that this was a high-status group of buildings. Many everyday artefacts were found during the excavations, giving clues about how people lived and worked in Culross 400 years ago.

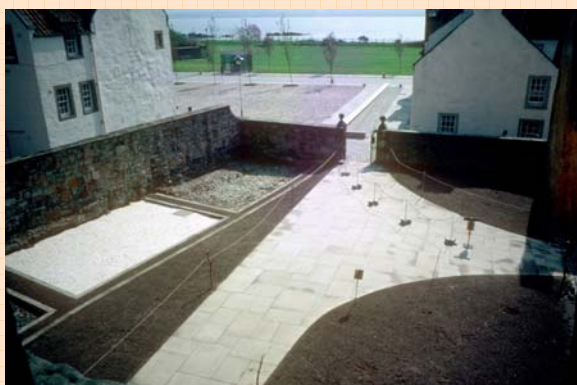
The reconstructed courtyard, with the smithy (white) marked out on the left

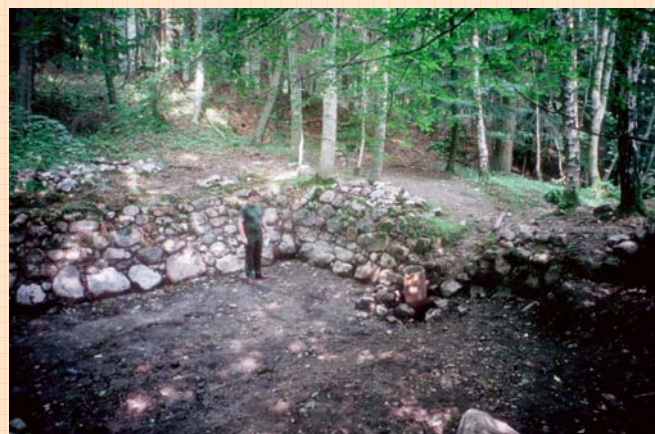
The Crathes ice pond after excavation, showing the roughly-cobbled bottom, sloping up for ease of access

Staff on the Crathes estate in Aberdeenshire had long wondered about the small square depression hidden in the woods. On closer investigation this was identified as an ice pond, used to encourage the formation of ice to feed the ice houses on the estate.

The pond is part of a simple yet effective system that includes a reservoir of unfrozen water and a canalised stream leading to the pond. The pond was probably last used in the 19th century, and was re-excavated by local volunteers under professional supervision.
